Explosion of a solvent drum

11th January, 2006

**Saint Marcellin (Isère)
France**

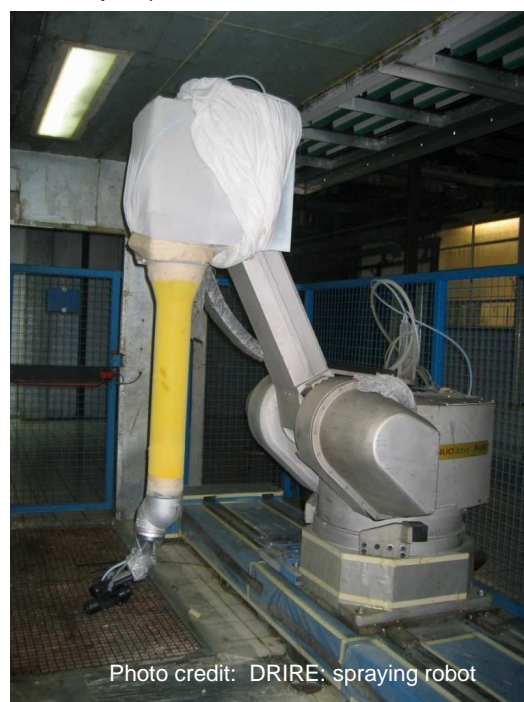
Photo credit: DRIRE: spraying robot

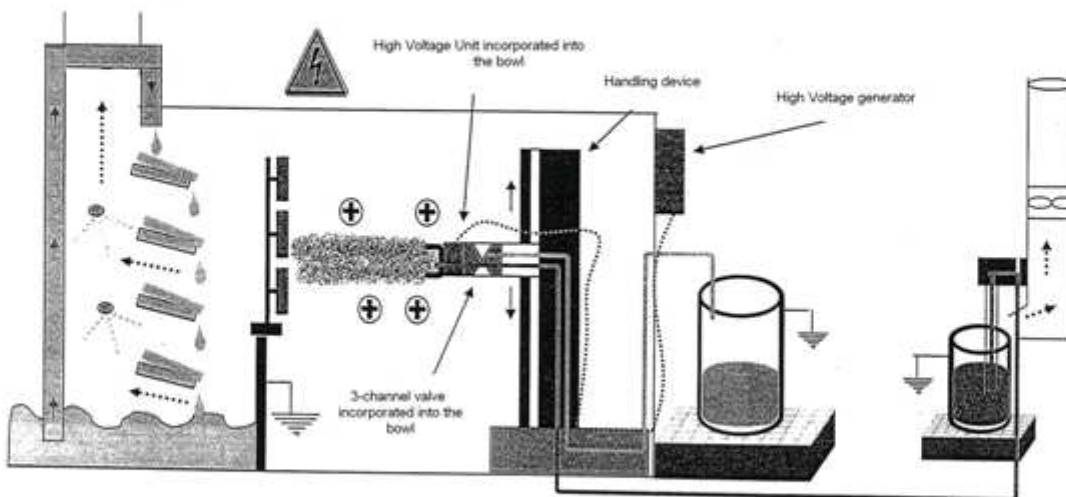
Schematic diagram - Application booth in electrostatic mode - UNI3 line

The most plausible scenario adopted focused on an air / solvent explosive atmosphere present in both the drum cap and immersion rod. The spraying bowl's residual electrostatic charge was transferred to the cleaning solvent (with a charge dissipation time, as verbally announced by the supplier, of 7 seconds, which exceeds the lapse in solvent intake). The solvent maintained its charge in passing through the pipe that connected the bowl with the immersion rod (insulated pipe) and caused a spark upon contact with the metal end of the rod. This spark, in turn, triggered ignition of the vapour space of both the rod and drum, ultimately inducing the air / solvent mix to explode.

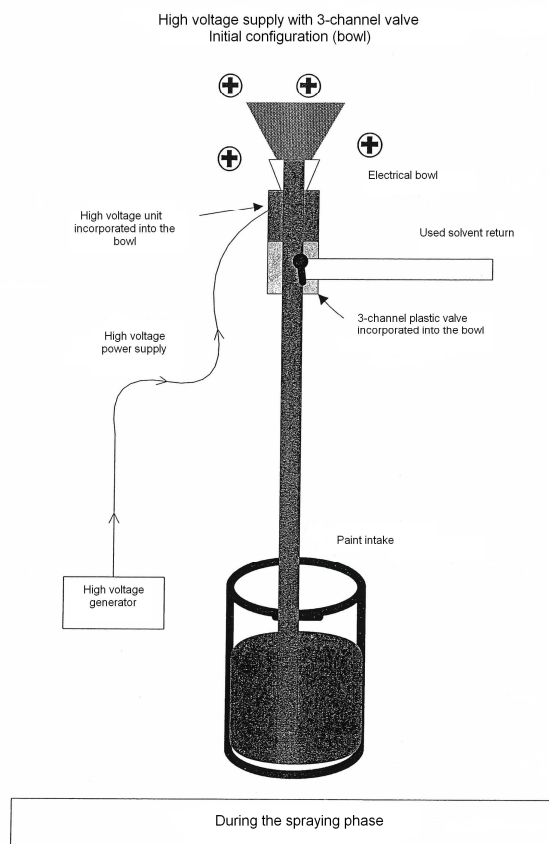
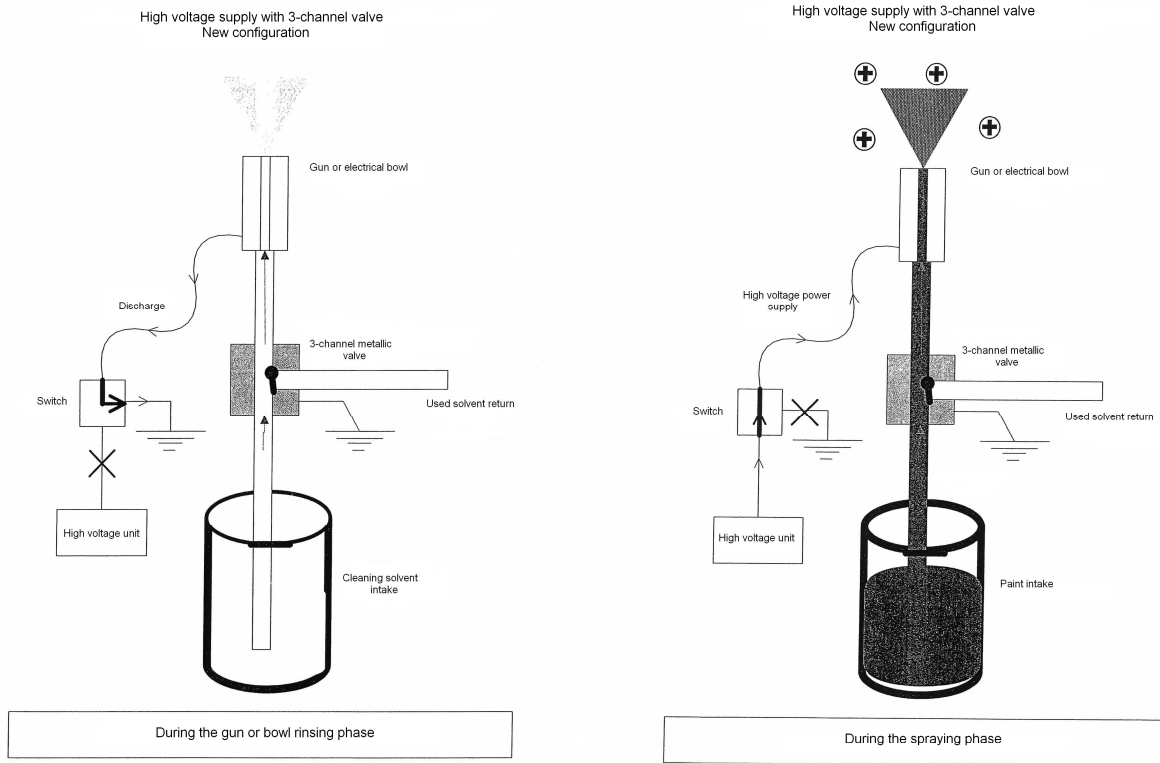
Restarting the damaged line was contingent upon submission of the expert's report containing a specific study on the electrostatic risk relative to the line's future configuration (as the most plausible accident scenario). This study was conducted by a certified body recognised for its competence in the field of static electricity. The expert appraisal was mandated to include the set of recommendations issued by the expert, i.e.: spraying robot ventilation, fire detectors in all spraying booths, sealed ductwork for running the robot's electrical cables, estimation of the maximum energy released by the robot, shutoff of solvent rinsing and drum recovery circuit while awaiting conclusions of the accident evaluation. On 25th August, a fire had previously broken out at the site (ARIA 30491), prompting preventive action to be undertaken on the very same day to improve drum grounding by the insertion of 3 cable clips.

- removal of the solvent recovery drums from operations while awaiting a more secure solution. The rinsing solvents were thus routed directly into the water curtain inside the booth;
- installation of a 3-channel grounded metal valve (or an equivalent device in the case of the UNI3 basic treatment booth) upstream of the bowls and guns;
- introduction of a switch that guarantees grounding between the spraying and cleaning phases.
