Gas explosion on an urban street
28 February 2008
Lyon (Rhône)
France

Pipeline / distribution
 Natural gas
 Explosion
 Road works
 Urban area
 Victims
 Property damages

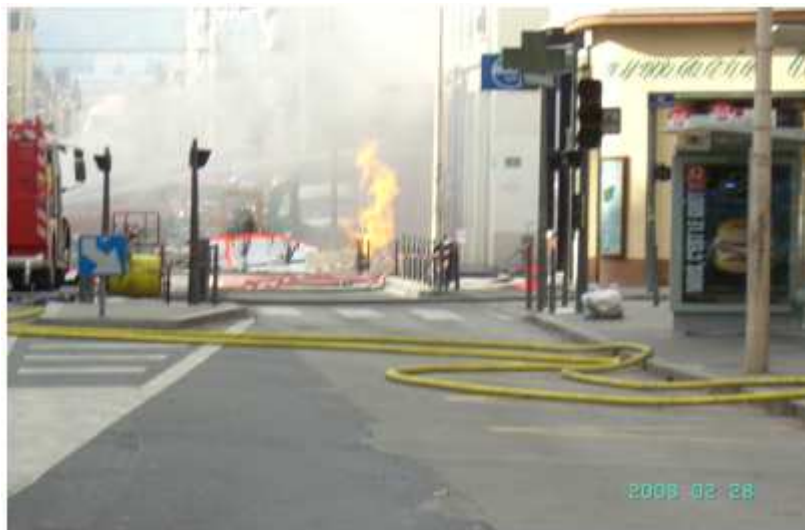
Around 12:15 pm, a gas explosion occurred at the level of 117 Cours Lafayette, causing the death of one fire-fighter and injuring 40 peoples, including 14 fire-fighters, 5 police officers and 2 gas technicians. In all, 1,000 people had to be evacuated in the vicinity of the explosion. A gas leak ignited shortly after the explosion in front of the building at 119 Cours Lafayette. The "code red" emergency plan was activated within the Rhône Department in order to deploy emergency services, resulting in the mobilization of some 100 fire-fighters and over 300 police officers.

Ignited gas leak following the explosion - Source: DREAL (Regional Environmental Agency) Rhône-Alpes

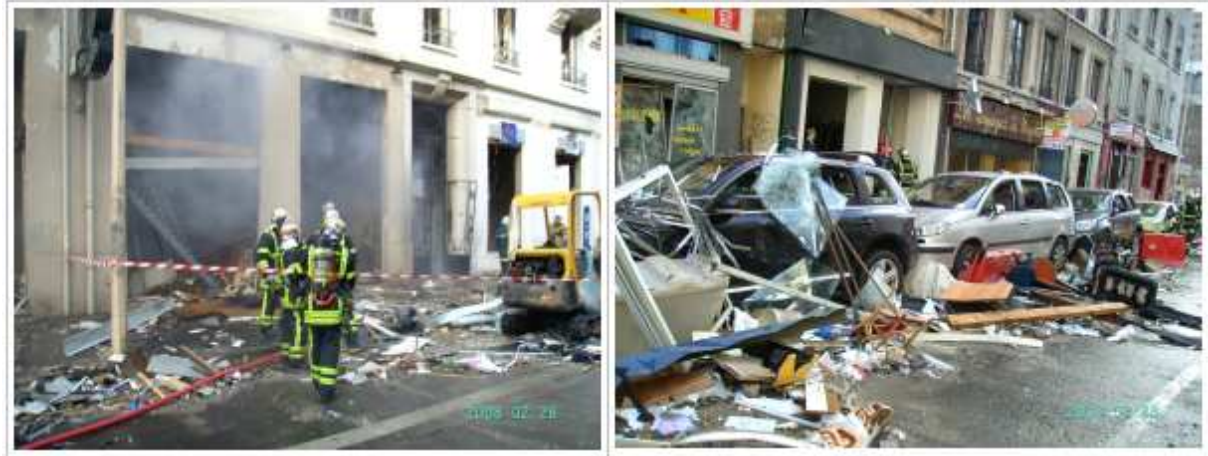
Property damage to buildings and cars parked in front of 117 and 119 Cours Lafayette was considerable and even extended to the rue Moncey cross street (see map on page 1 and accompanying photographs).

Property damage - Source: DREAL (Regional Environmental Agency) Rhône-Alpes

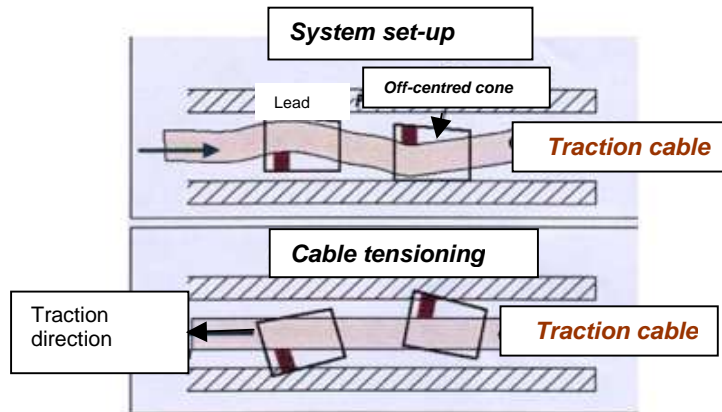
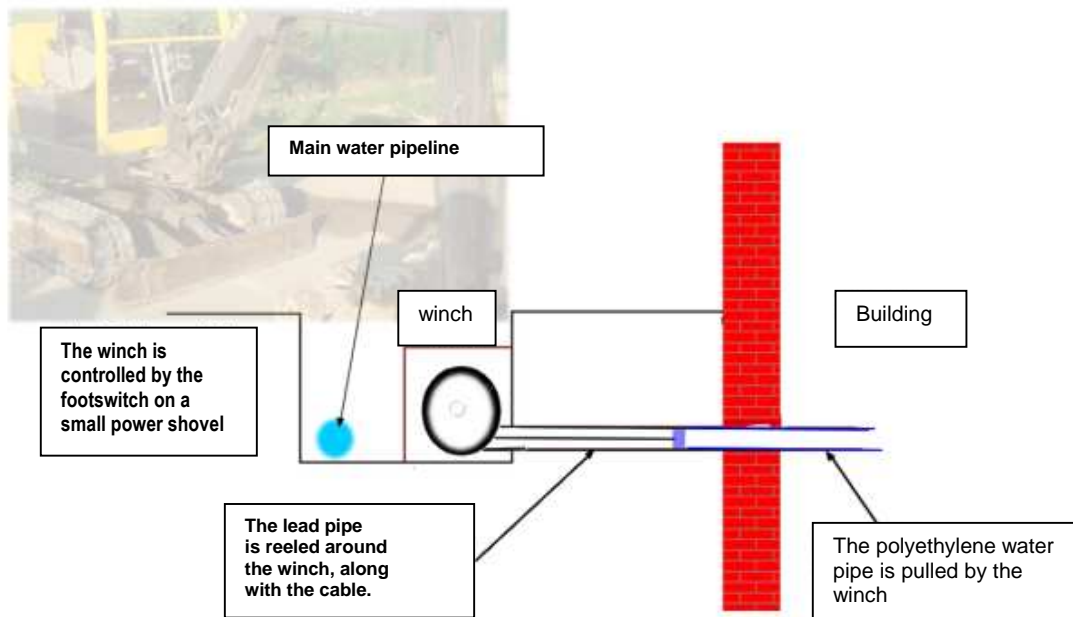
- excavating a shaft at the spot where the lead pipe was hooked up to the main water intake line;
- cutting lead connection pipes at the level of the shaft and inside the building being supplied;
- sliding a metal cable into the lead pipe until it reached the interior of the building;
- fastening a cable clamp at the end where the polyethylene pipe (designed to replace the lead pipe) was attached;

- installing a winch at the bottom of the shaft to draw the metal cable and then drag with it both the lead and polyethylene pipes.

Schematic diagrams of the contractor's method - All rights reserved

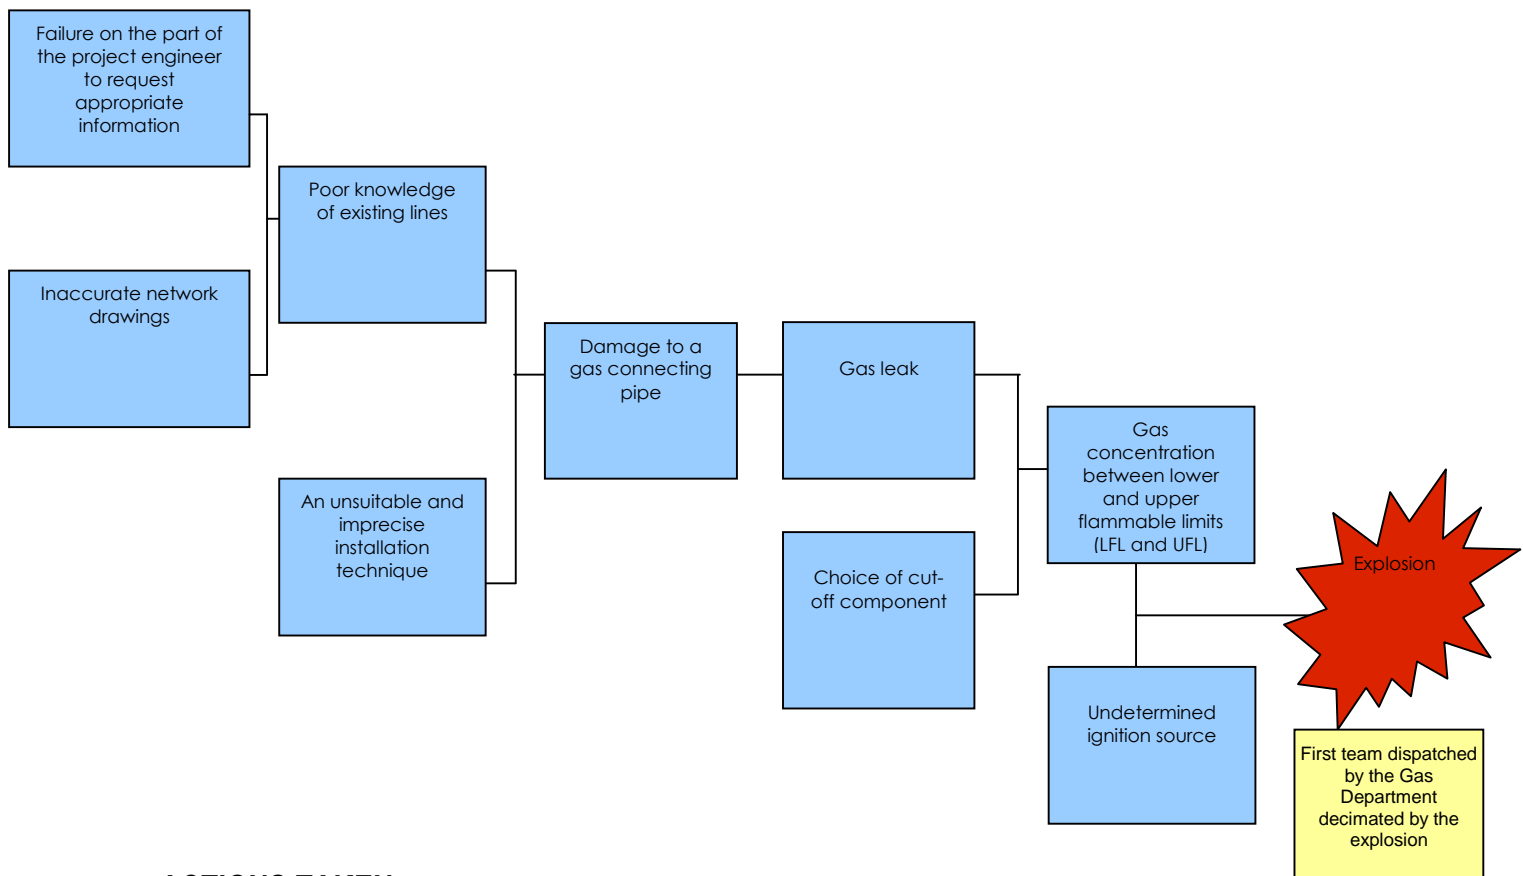
The accident occurred right at the time the public works contractor was extracting a lead water pipe. Natural gas leaked out at the level of an expansion chamber, as evidenced by finding the chamber lid on the Cours Lafayette sidewalk. The gas then spread into basements and ground floors of the buildings at addresses 117 and 119. Gas ignition due to an undetermined source then caused the explosion.

Without the benefit of conclusions from ongoing judicial action, the gas explosion could be schematically explained as follows:

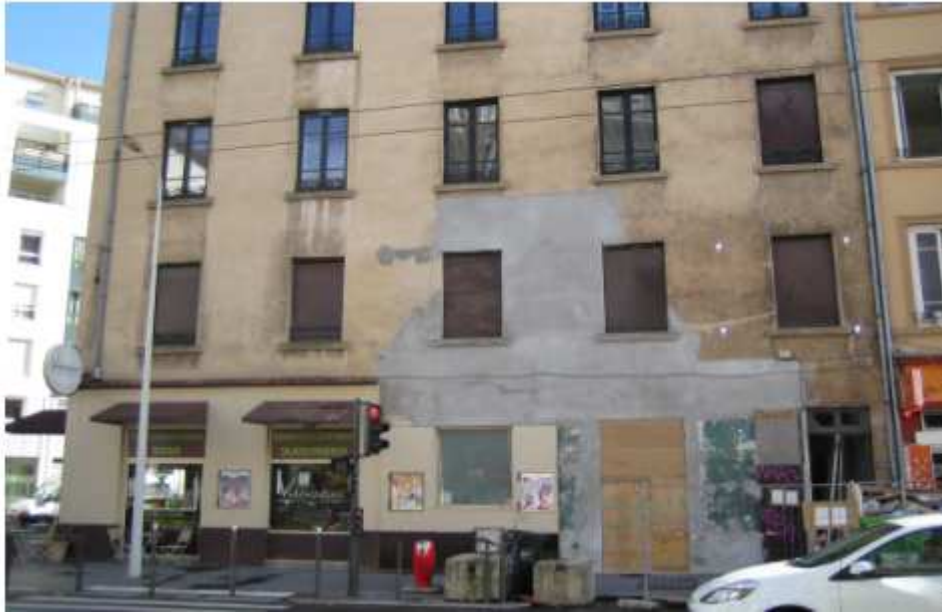
As of April 2012, the building at 128 Cours Lafayette (opposite no. 119) was still undergoing rehabilitation and remained unoccupied.

128 Cours Lafayette - photograph taken in April 2012 - Source: BARPI

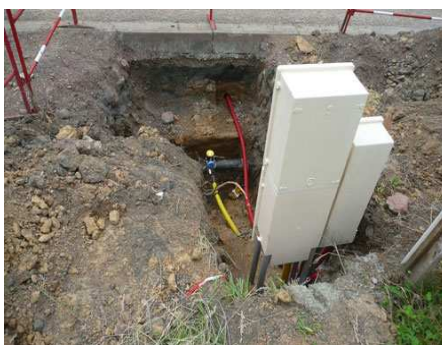
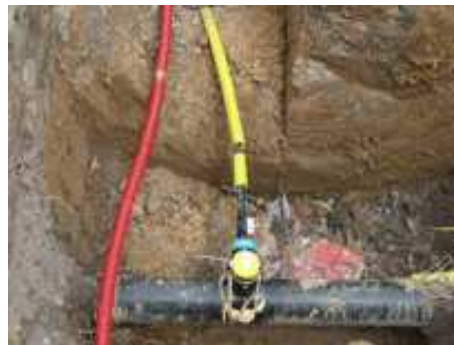
Photographs of a gas connection pipe - the distribution pipe is shown in black (the connection is visible by a yellow cap), and the gas pipe extending from a residence's gas cabinet is in yellow - All rights reserved.

- Connection pipes between the gas distribution network and residential pipes must be better protected in light of the large number of worksites in their vicinity and their vulnerability when subjected to a shock.
