Explosion of an ammonia tank

March 24, 1992

Dakar

Tank rupture

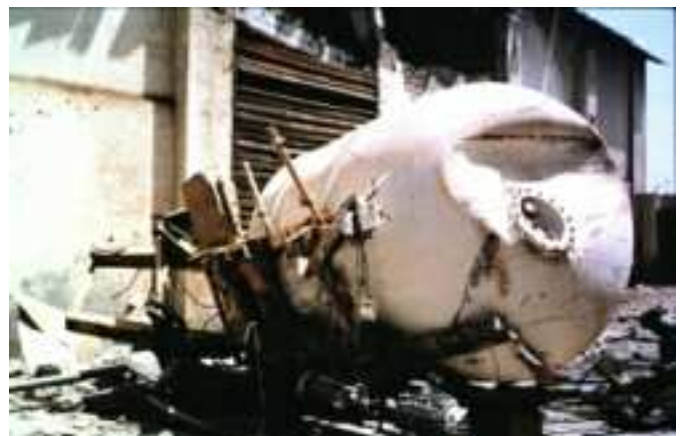
Photo: R.D.

The next day at 1.30 pm, the tank suddenly burst open along the central shell which rolled out completely flat. The front and rear of the tank, while only very slight deformed, were propelled by the force of the reaction.

In a more or less horizontal trajectory, the front of the tank clipped part of the installations then smashed into the wall of an electrical service building. The trajectory of the rear of the tank is more difficult to establish. Based on the findings, it appears that it was propelled upward at approximately a 45° angle. After colliding violently with a massive reinforced concrete lintel, it ricocheted toward the detoxication installation, causing significant damage to the unit's upper levels.
