Uncontrolled emissions subsequent to a decomposition reaction inside a dryer

19 November 2011

Lanester (Morbihan)
France

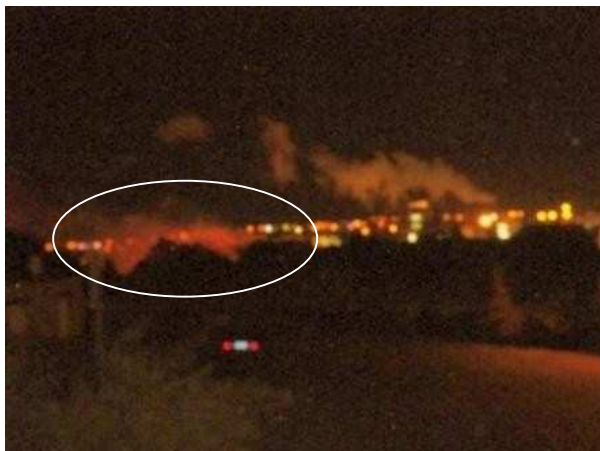
Photograph of the cloud before its dispersion

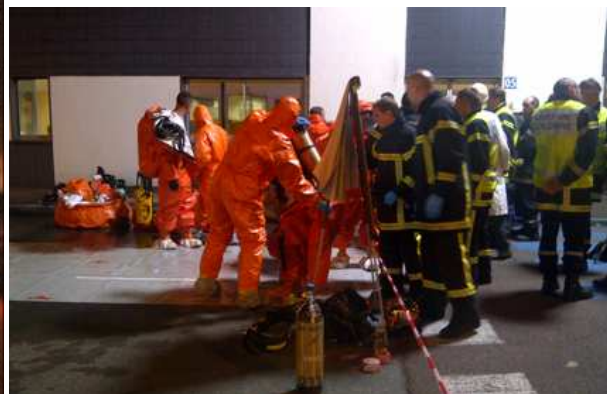
Fire-fighter intervention wearing diving suits

been obstructed by the substances being released. Responders had to wear diving suits to survey the premises, during which they determined that the emissions had originated from a burst glass tube connected to the DICOA dryer, which was still being heated and whose contents had begun decomposing.

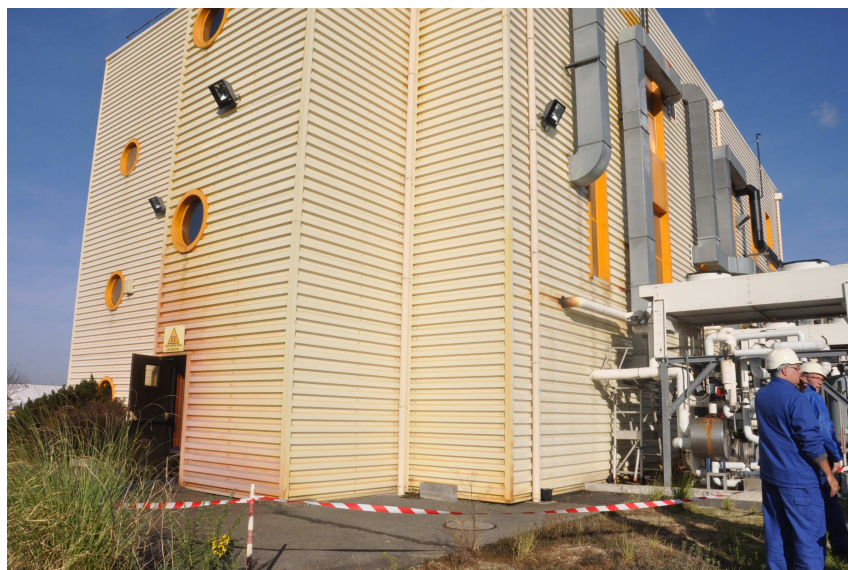
The initial mass of wet DICOA (solvent = water + ethanol) present in the dryer amounted to approx. 1.8 tonnes, i.e. on the order of 1.4 tonnes of dry DICOA. A portion of the decomposed product remained in the dryer (about one-third of the initial mass was found inside) and in building B45, whose walls, floors and ceilings had been covered by a pinkish deposit. The quantity released outside the site could not be accurately determined.

A major clean-up effort was required inside building B45 due to the presence of deposits (see photo).

Traces of reddish deposit on building B45 - Source: DREAL Environmental Agency (Brittany)
