Explosion in a zinc refinery

16 July, 1993

**Noyelles-Godault [Pas-de-Calais]
France**

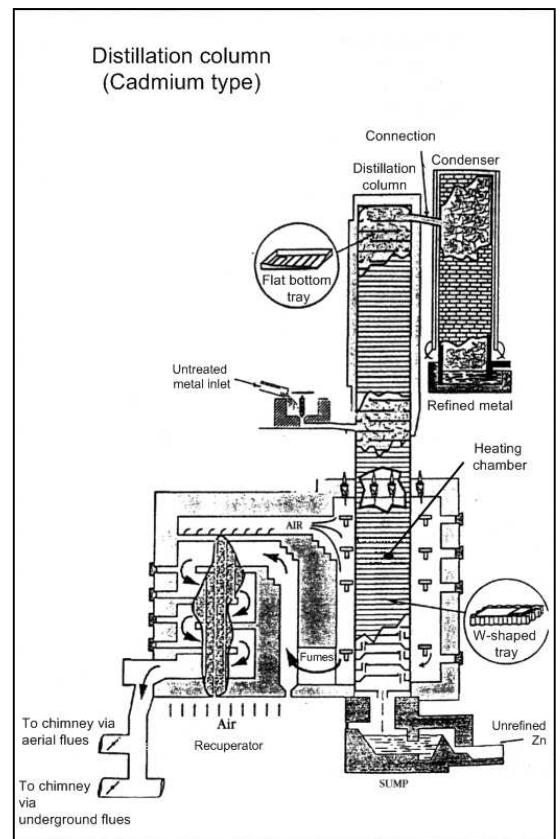
The concerned "cadmium" column is 13m high and comprises a stack of 59 silicon carbide trays heated to 1,000°C. A briquetted heating chamber built around the lower part of the column houses eight natural gas burners and a smoke heat recuperator. The chamber is maintained in low pressure. The top tray of the column is connected to a condenser by a pipe.
