Explosion of a solvent drum

11th January, 2006

**Saint Marcellin (Isère)
France**

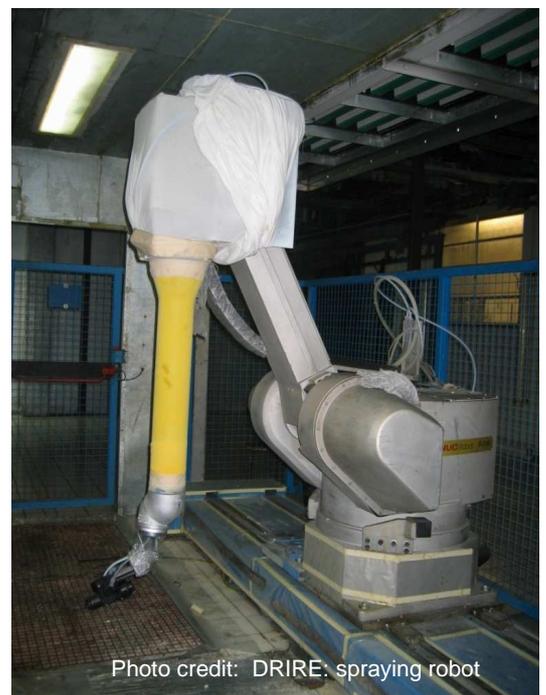
Photo credit: DRIRE: spraying robot

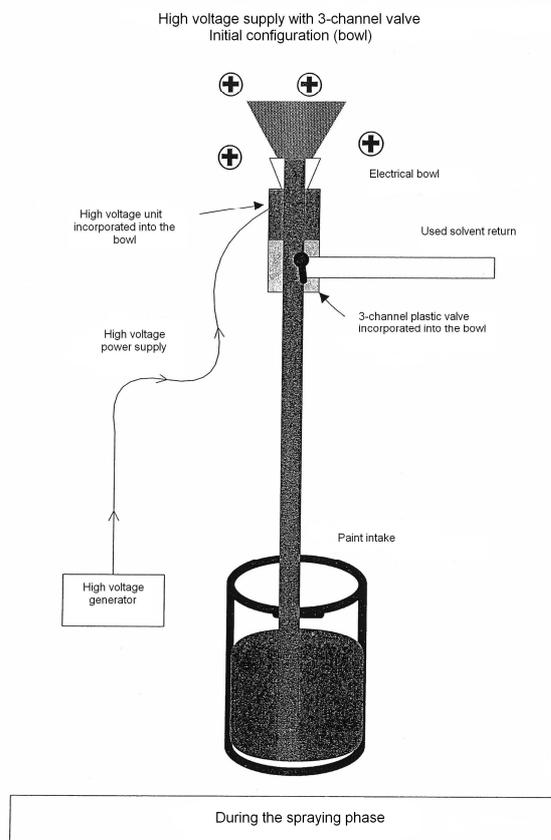
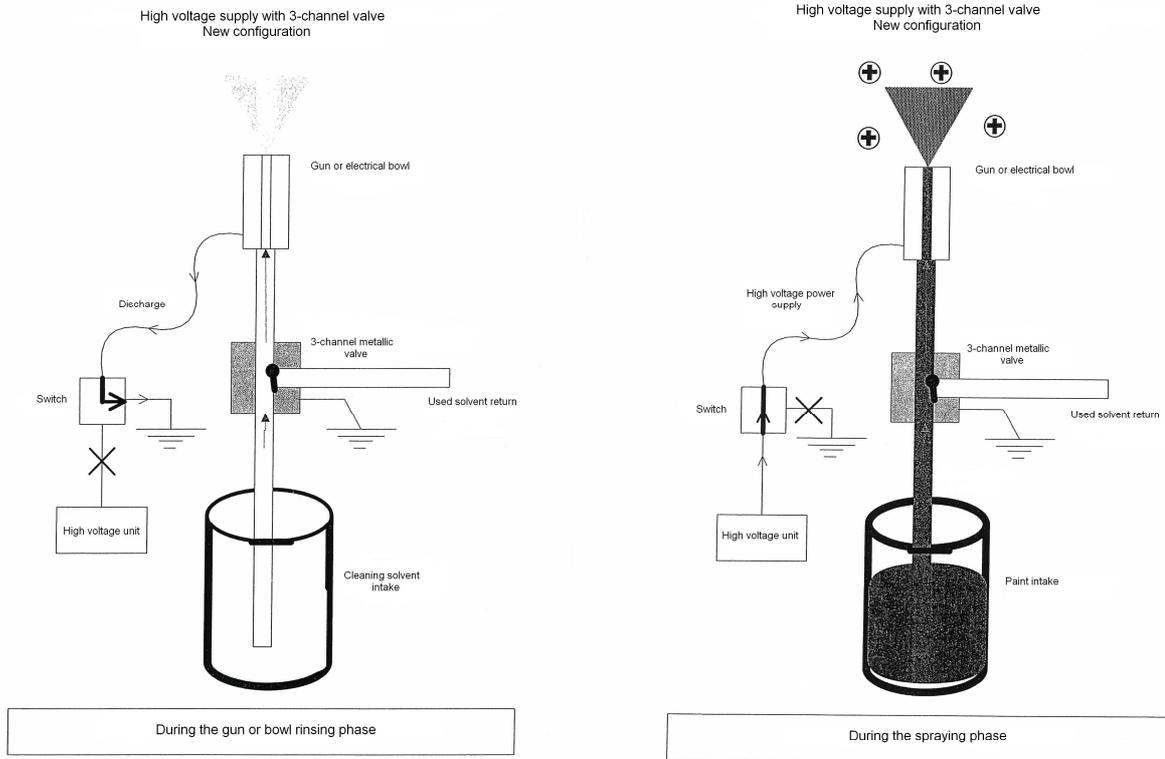
Restarting the damaged line was contingent upon submission of the expert's report containing a specific study on the electrostatic risk relative to the line's future configuration (as the most plausible accident scenario). This study was conducted by a certified body recognised for its competence in the field of static electricity. The expert appraisal was mandated to include the set of recommendations issued by the expert, i.e.: spraying robot ventilation, fire detectors in all spraying booths, sealed ductwork for running the robot's electrical cables, estimation of the maximum energy released by the robot, shutoff of solvent rinsing and drum recovery circuit while awaiting conclusions of the accident evaluation. On 25th August, a fire had previously broken out at the site (ARIA 30491), prompting preventive action to be undertaken on the very same day to improve drum grounding by the insertion of 3 cable clips.

- removal of the solvent recovery drums from operations while awaiting a more secure solution. The rinsing solvents were thus routed directly into the water curtain inside the booth;
- installation of a 3-channel grounded metal valve (or an equivalent device in the case of the UNI3 basic treatment booth) upstream of the bowls and guns;
- introduction of a switch that guarantees grounding between the spraying and cleaning phases.
