# Small or big changes, not managing them can be risky!

## Bureau for Analysis of Industrial Risks and Pollutions (BARPI), France

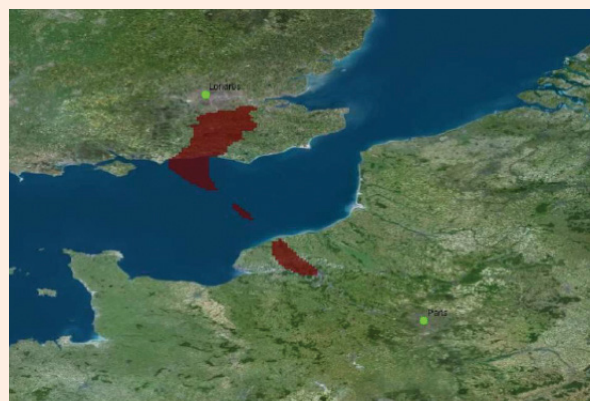
At around 8 a.m., a technician detected an odour of mercaptans in the alkylation unit of a chemical site. A

sample of the product was taken pending transfer (two days) to a control tank when the high-temperature alarm was triggered. At around 9 a.m., analyses were able to confirm the product's breakdown. The gas treatment plant became saturated and an odorous cloud drifted off the site. The facility operator triggered the plant's emergency plan, alerted the Prefecture and the 33 communities likely to be affected. Several neutralisation tests were conducted during the day but were unsuccessful. Odours were detected throughout the entire region, Paris and into the south of England. Tens of thousands of people reported feeling ill, complaining of vertigo, vomiting, etc. Over the following three days, a new procedure was able to neutralise little by little the 36 t of decomposing product.

- Inadvertent start-up of the tank's agitator three days earlier. The batch was transferred the following day at 94°C. It gradually heated up as a result of friction until it began to decompose thermally at around 110°C;
- The tank had been transferred from another unit 16 years earlier with an agitator and insulation that were unnecessary for the process — no change management process had taken place;
- The agitator, which had been locked out in 2006, was no longer locked out due to a poorly controlled maintenance intervention;
- The risk analysis did not identify the product's risk of decomposition at around 110°C.

The facility operator removed the thermal insulation from the tank, installed appropriate cooling facilities, modernised the operation of the unit and resized the gas treatment operation. The intervention procedures were improved, the technicians received training on how to deal with emergency situations, the changes made on the equipment that was installed 16 years ago were analysed and the inspection procedures were improved.

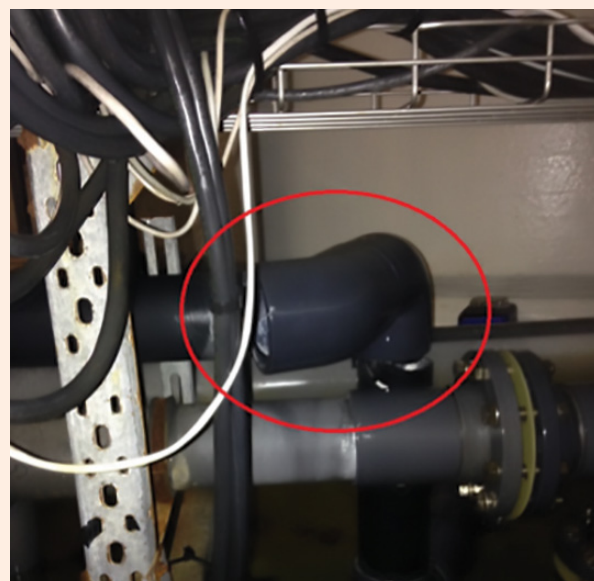
A technician conducting rounds in the storage facilities of a household detergent packaging plant discovered that the retention basin (for two tanks) in the storage facility was full of bleach. The retaining basin was not sealed, and 30 l of product was able to enter the rainwater network. The product contained in the retention basin was pumped into an empty tank. The rainwater network was pumped to an empty container. The container, having previously contained acid, released chlorine vapours and slightly intoxicated an employee. It was estimated that approximately 83.5 tonnes of 2.6% bleach was released.

Four months prior, the operator had done away with the night shift that was in charge of transfers between storage tanks and packaging lines. On the night of the accident, the production crew was to fill bleach containers. A technician went to the storage facility's control station at around 10 p.m. From the control desk, he was able to start the transfer pump and then opened the bottom valve on the corresponding tank. Water hammer began due to pumping with the valve closed. As a result, an elbow downstream from the valve became detached from its piping. The leak was discovered only two hours later. The level sensor on the retention basin was out of order.

The subsequent investigation revealed that insufficient instructions were provided regarding the transfer operations and that the production team was not trained in how to use the transfer control station.
