## Fatal accident due to asphyxia by H<sub>2</sub>S

February 15th , 2001

Baupte – [Manche]

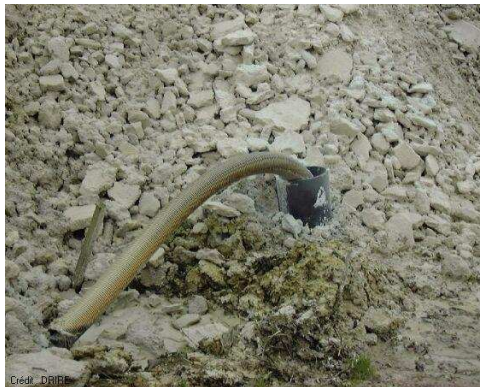
Until 1999, the filter cakes were stored on a non-hermetic storage area. In order to reduce the environmental impact of this storage facility, since 1999 the area consists of a central paved portion of 3,000 m<sup>2</sup> and a peripheral portion made of compacted earth measuring 2 x 1,825 m<sup>2</sup>. It is now possible to recover the drainage runoff.

The entire area is isolated from the subgrade by a geotextile membrane then by a geomembrane and is equipped with a drainage network and a degassing vent system. The latter system consists of a honeycomb structure placed underneath the lower geomembrane.

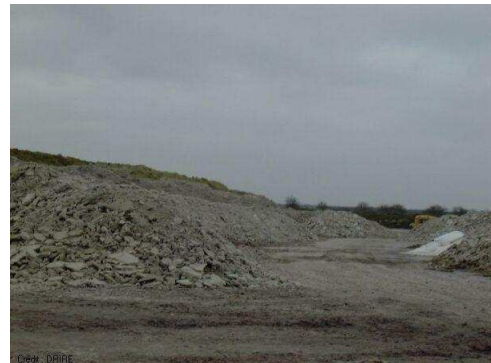
The drainage water is recovered in two sumps, one of which is equipped with a "cellar drainage pump" which conveys the leachates to the site's effluent processing station. This pump is controlled by a level float.

The operator has foreseen to modify the pump's discharge line to avoid having to enter the sump. This modification, however, cannot be made until the judicial authorities in charge of the inquiry have granted authorisation.

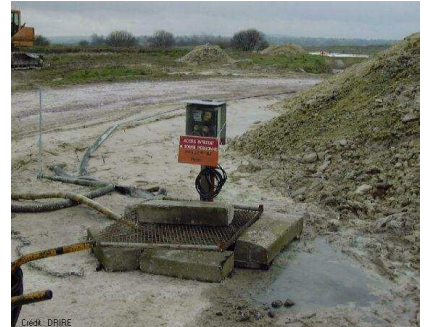
On February 15, 2001, two company employees performed maintenance on a sump pump used to recover drainage runoff from the filter cake: according to the site Director, owing to the design of the drainage system, the hose connecting the pump discharge to the line going to the treatment plant comes disconnected relatively frequently.

In this case, the following operation is performed:

- ✓ the sump is drained using a motor-driven pump,
- ✓ the pump is removed from the sump using a chain,
- ✓ the hose is reconnected,
- ✓ the pump is placed back in the bottom of the sump and the flange is replaced.

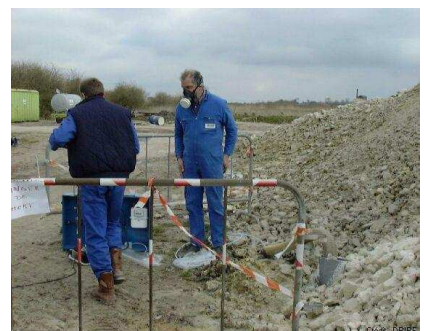
An organisation requisitioned by the District Attorney, conducted atmospheric measurements by chromatography in a mobile laboratory, just a few days after the accident.

The results of the measurements taken in the sump are as follows:

- ✓ sump totally full: NTR,
- ✓ sump drained to the level of the pipe bringing the drainage runoff: 222 ppm of H<sub>2</sub>S. (Note: when the pump was stopped, the concentration of hydrogen sulphide in the sump went from 222 to 6 ppm in approximately 20 minutes).
- ✓ Sump completely drained: 550 ppm of H<sub>2</sub>S. (In the bottom of the sump, the concentration of hydrogen sulphide reached 2,270 ppm).
- ✓ Average methane content: 300 ppm (0.03%).
- ✓ Oxygen concentration: approximately 20%.
- ✓ Carbon dioxide concentration: 0.1 to 0.2%.
