Gas explosion on an urban street
28 February 2008
Lyon (Rhône)
France

Pipeline / distribution
 Natural gas
 Explosion
 Road works
 Urban area
 Victims
 Property damages

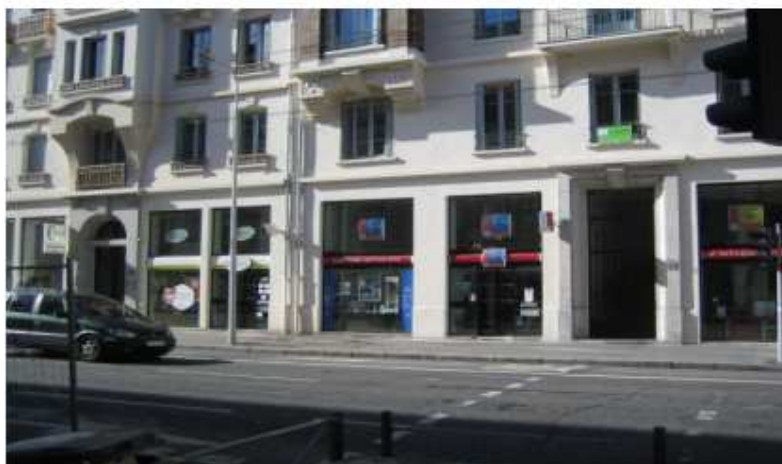
Building addresses 117 and 119 Cours Lafayette - Photograph taken in April 2012 - Source: BARPI

Property damage to buildings and cars parked in front of 117 and 119 Cours Lafayette was considerable and even extended to the rue Moncey cross street (see map on page 1 and accompanying photographs).
